OUTDOOR PLAY AREA TYPE: ANNUAL INSPECTION

INSPECTION REPORT

Mill lane play area at DE65 5GG, Village hall site at DE65 5GH,

Date of inspection: 18th February 2025

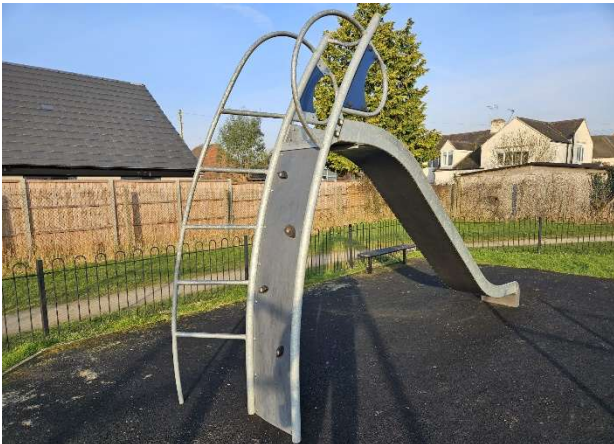
<p>The following standards were used for the inspection:</p> <p>BS EN1176 part 1:2017 General BS EN 1176-3:2017 Slides BS EN1176 part 7:2020 Inspection</p> <p>No deviation found</p>

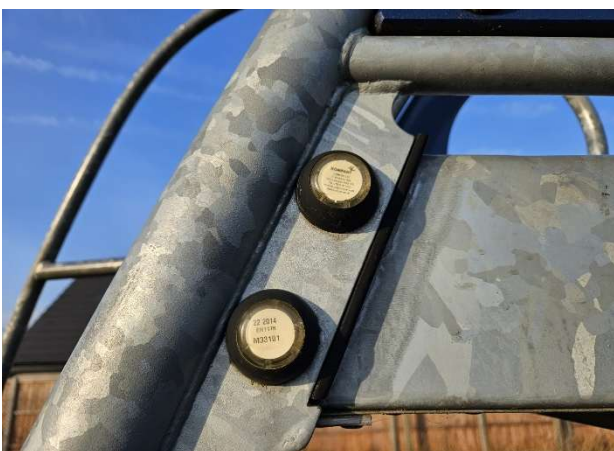
<p>The following standards were used for the inspection:</p> <p>BS EN1176 part 1:2017 General BS EN 1176-3:2017 Slides BS EN1176 part 7:2020 Inspection</p> <p>No deviation found on Signage</p>

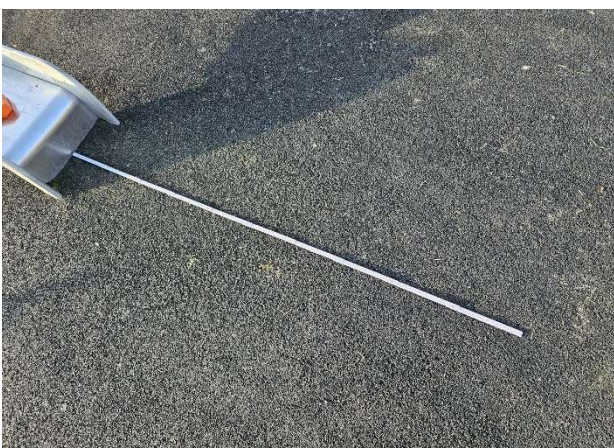
<p>The following standards were used for the inspection:</p> <p>BS EN1176 part 1:2017 General BS EN 1176-3:2017 Slides BS EN1176 part 7:2020 Inspection</p> <p>No deviation found</p>

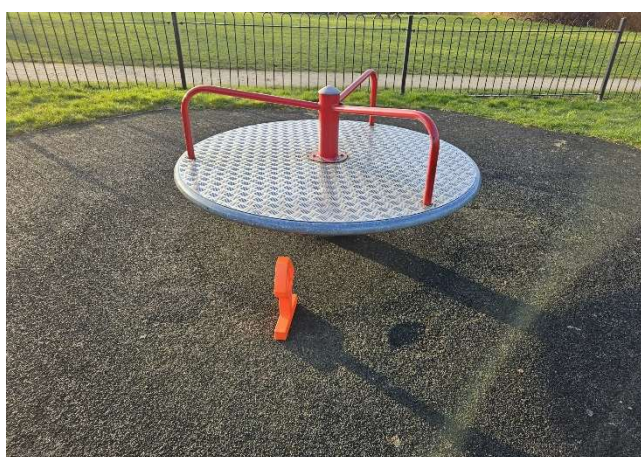
No deviation found

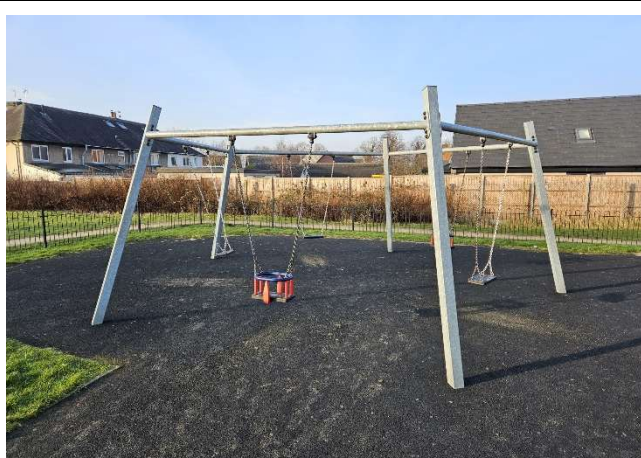
BS EN1176 part 1:2017 General
BS EN1176 part 7:2020 Inspection
BS EN 1176-2:2017+AC:2019 Swings

Deviation found

- 1) The Contact swing does not conform to the standards as detailed below.
For ease I would suggest installing a tyre on each of the three open swings, rather than installing the restraining bar.

5.3 Contact swings (Type 4) Seats shall be constructed to discourage jumping from them to the central axis while swinging.

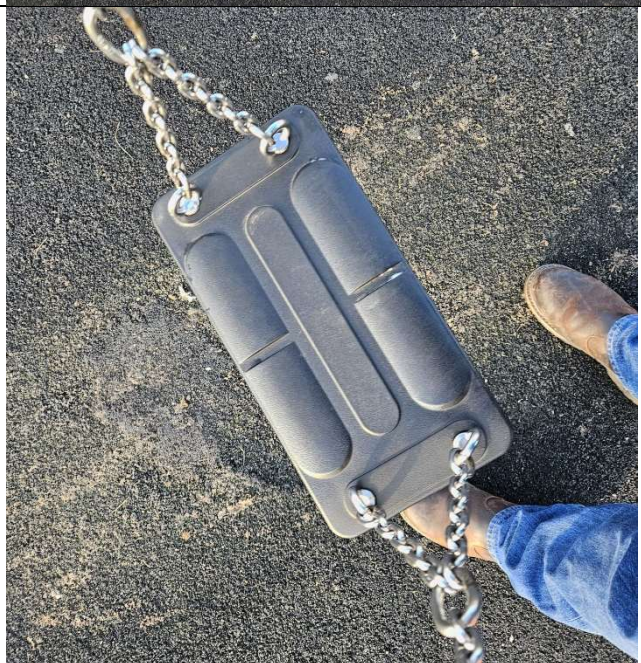
No deviation found

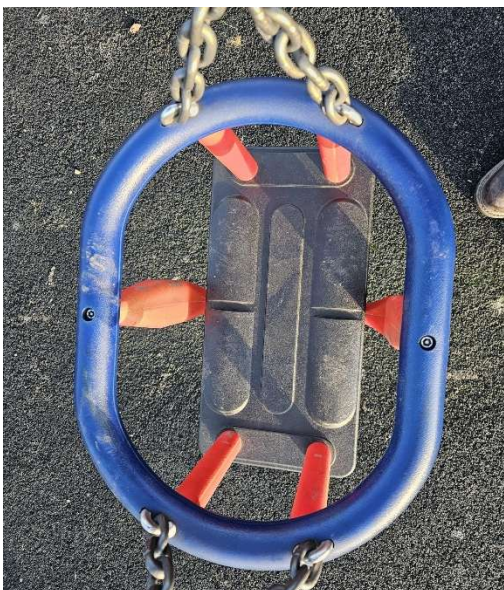
No deviation found

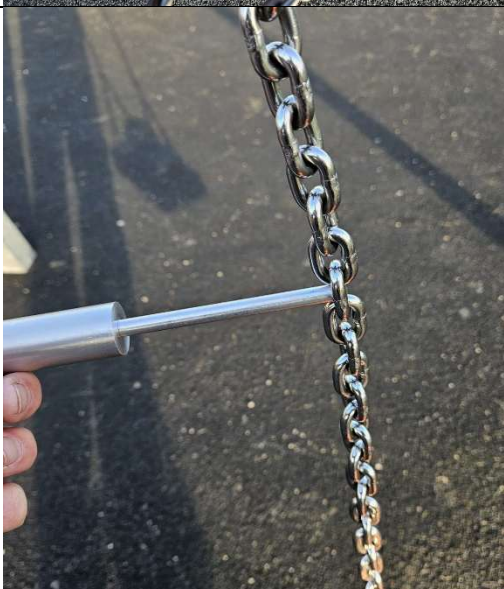
No deviation found

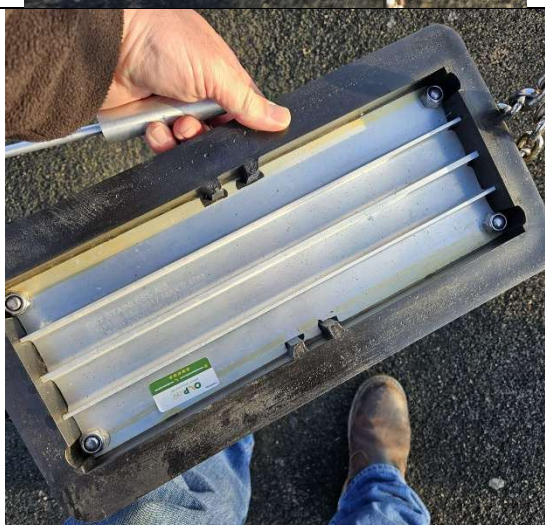
No deviation found

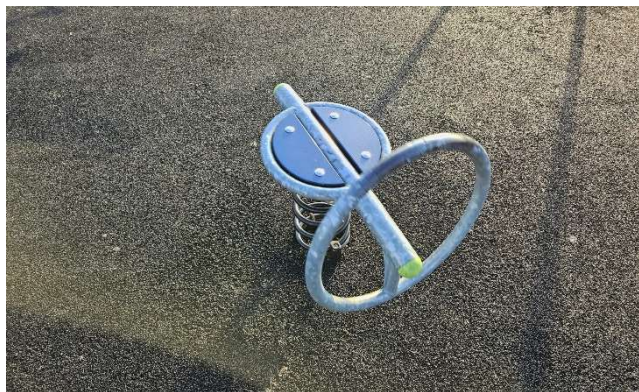
No deviation found

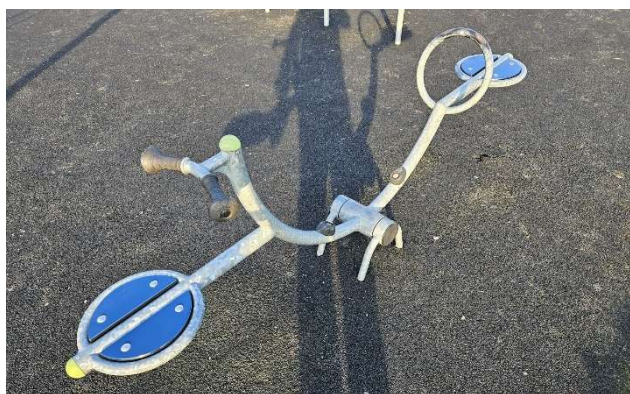
No deviation found

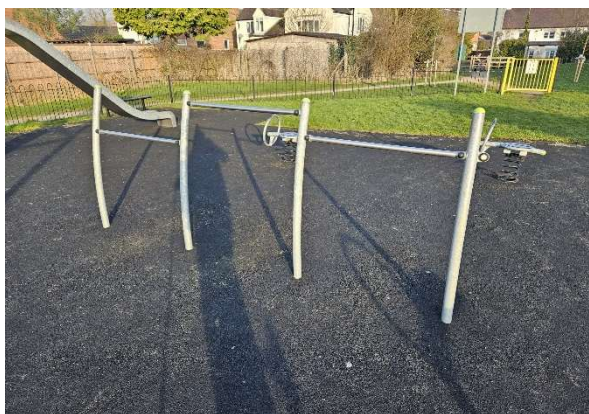
No deviation found

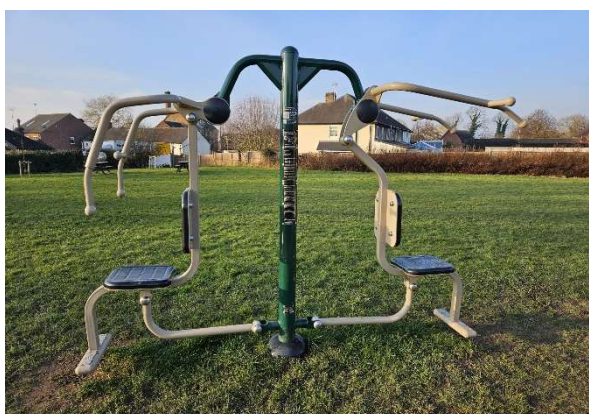
No deviation found

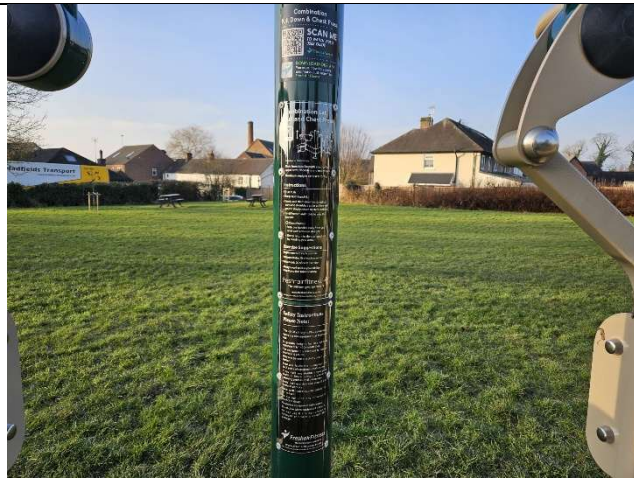
No deviation found

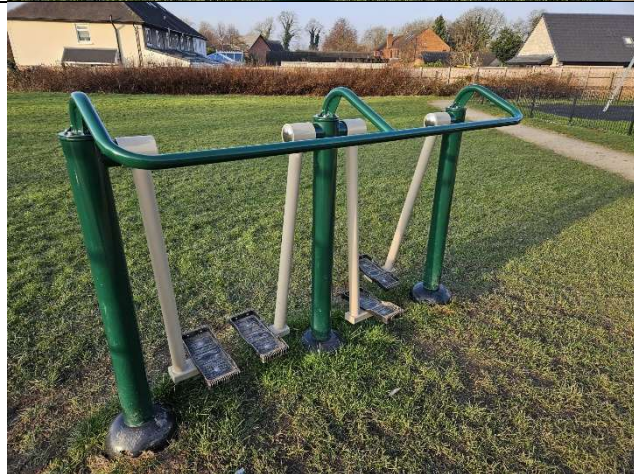
No deviation found

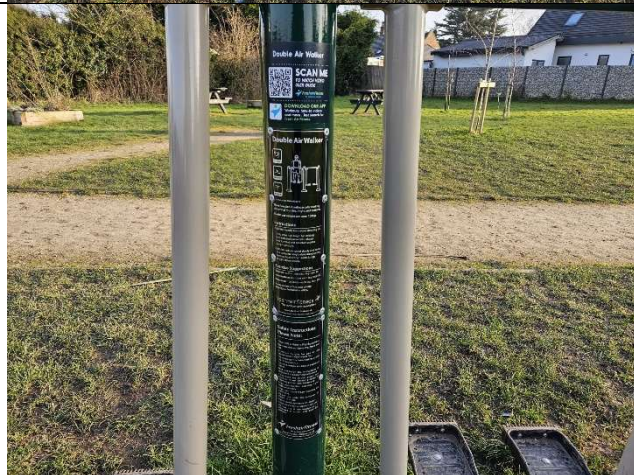
No deviation found

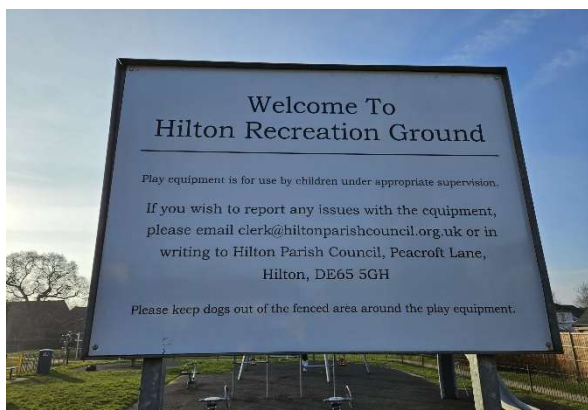
No deviation found on signage.

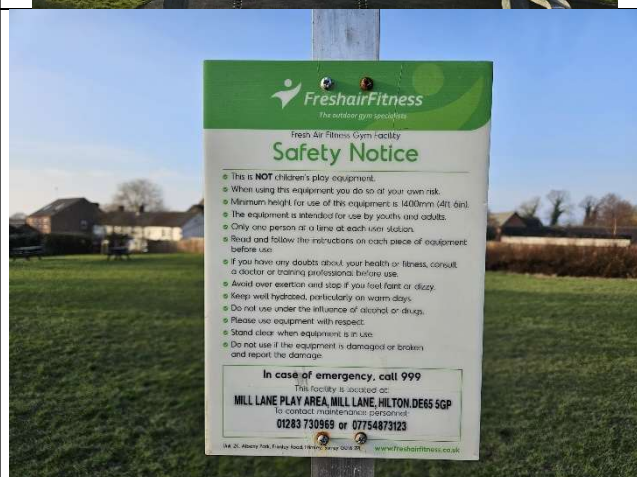
No deviation found on signage.

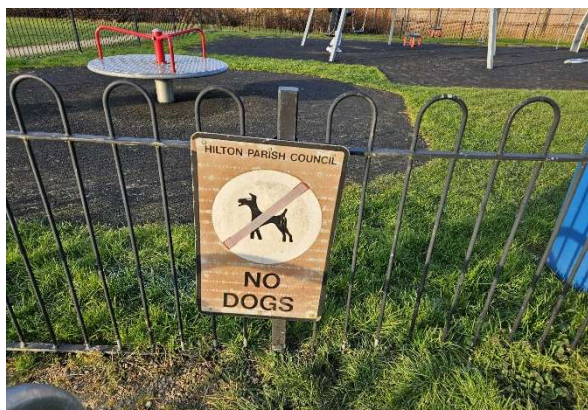
No deviation found on signage.

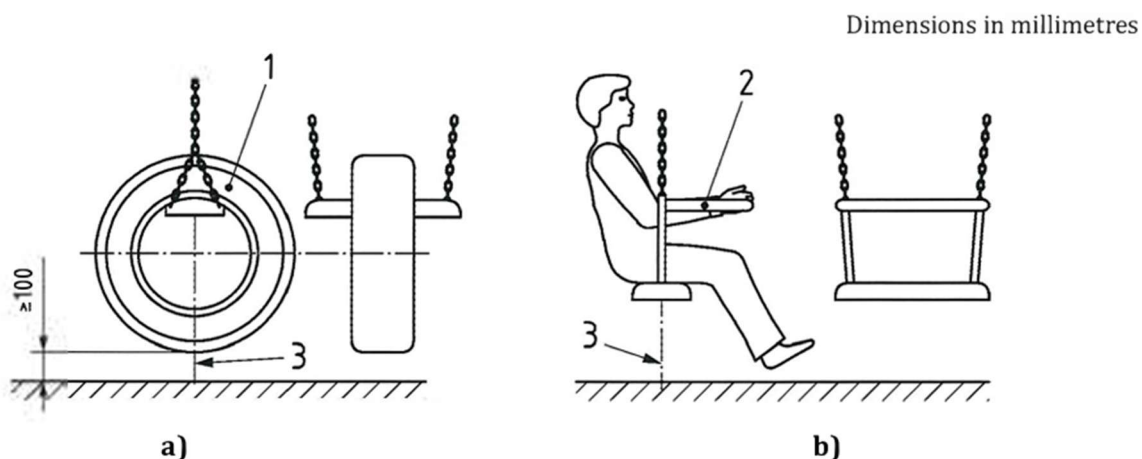
EXAMPLE This can be achieved by using a vertical tyre or a restraining bar, see Figure 12.
